## Ans: Horseshoe kidney

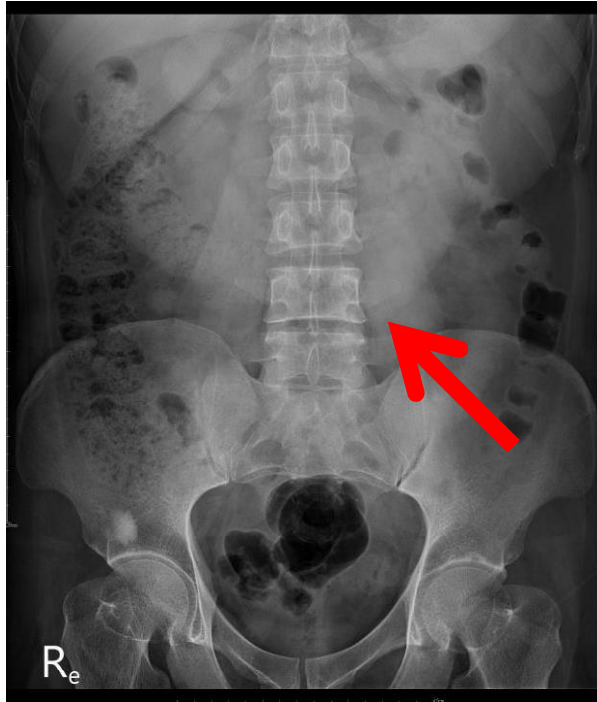
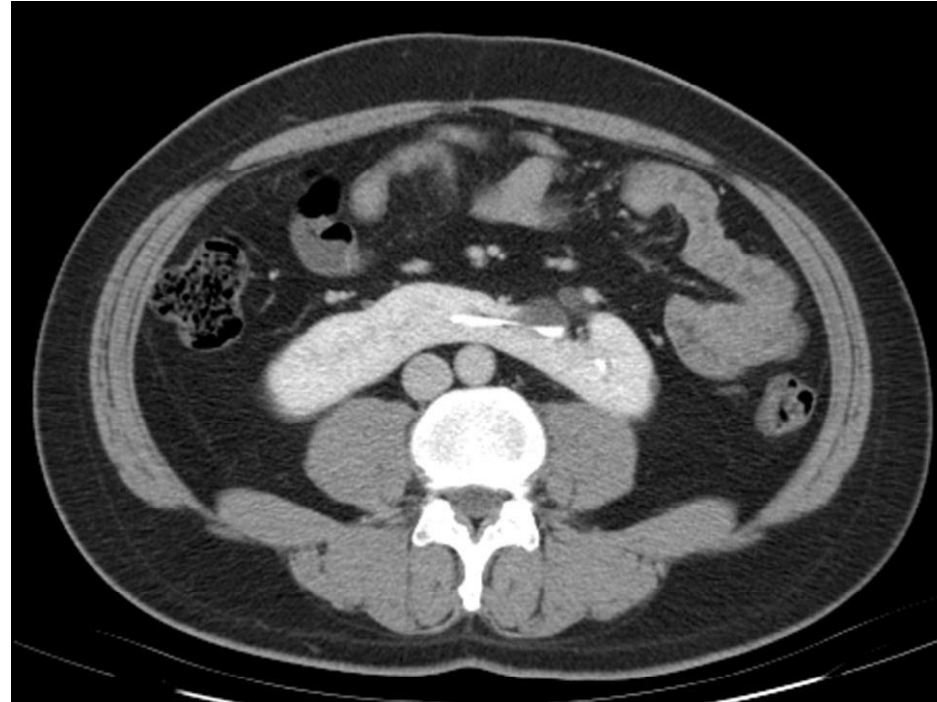
**Horseshoe kidney is a common congenital renal anomaly. It is characterised by fusion of the kidneys at lower poles in 90° which produces a horse-shoe shaped structure continuous across the midline. The isthmus cannot ascend past the inferior mesenteric artery and thus the kidney is low in position. The ureters arise anteriorly and there are commonly multiple renal arteries. The complications of horseshoe kidney are 1) urinary stasis with infection or stone formation, due to abnormal ureteric orientation, and 2) predisposition to traumatic injury, due to abnormal position.**
